PS handout
Item 2b
Finance
3/14/19

April 17, 2018

Structural System

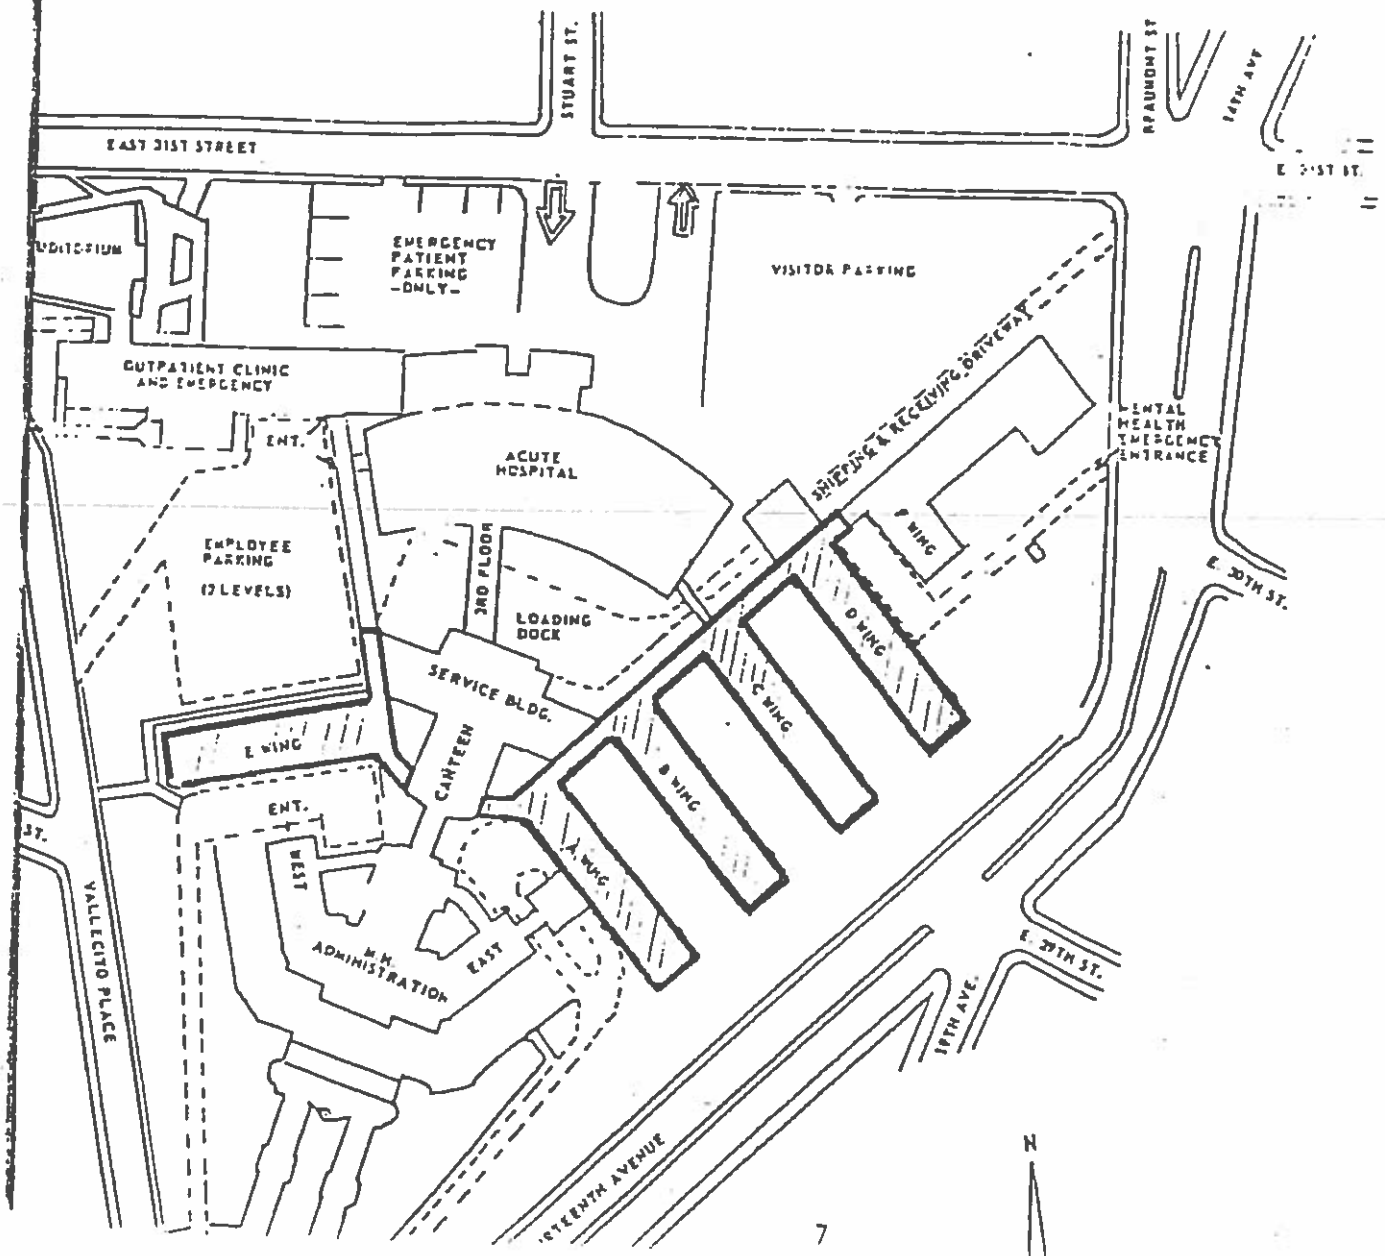
Wings A, B, C, D, and E each consist of a basement, three stories, and roof with penthouse. The wing buildings were designed by architect Henry Meyers, and built about 1921. Reinforced concrete beams, columns, bearing walls and concrete floor slabs support vertical loads. Reinforced concrete exterior walls, interior stair, and elevator shaft walls provide a minimal lateral load resisting system (see plans).

1. Wall reinforcement is less than code minimums.
2. Shearwalls have no trim bars at openings to resist lateral force bending moments.
3. Column tie size and spacing are inadequate.

1. Floor and roof diaphragms at the junctions between the wings and the corridors would be overstressed more than 125% in lateral force shear.
2. Shearwalls at both ends of the wings would be overstressed more than 700% due to lateral force bending moment.
3. Stairway and elevator wall foundations would be overstressed more than 200% in lateral shear transfer to ground. These walls have minimal footings.

1. The wing buildings are connected at their north ends by reinforced concrete corridors. These corridors are much more rigid than the wings. During a major earthquake, torsional stress at the junctions between the wings and corridors would probably cause failure of the floor and roof diaphragms and "break loose" the wings from the corridors.

2. After diaphragm failure, the remaining shearwalls in the "broken loose" wings would be overstressed to the point of collapse.

Wing Buildings A, B, C, D and E would be rated Poor to Very Poor according to the University of California Seismic Performance Rating System. (included later in this report). These buildings represent a high life safety hazard in their present condition.

Upgrading Wing Buildings, A, B, C, D & E would not be economical if they were required to meet all current structural requirements of Title 24. It would be difficult to add reinforcement to the columns and walls to correct the "Structural Deficiencies - Code Requirements" noted. In addition, the lateral force resisting system lacks the capacity required by Title 24, and new shearwalls with foundations would have to be added.

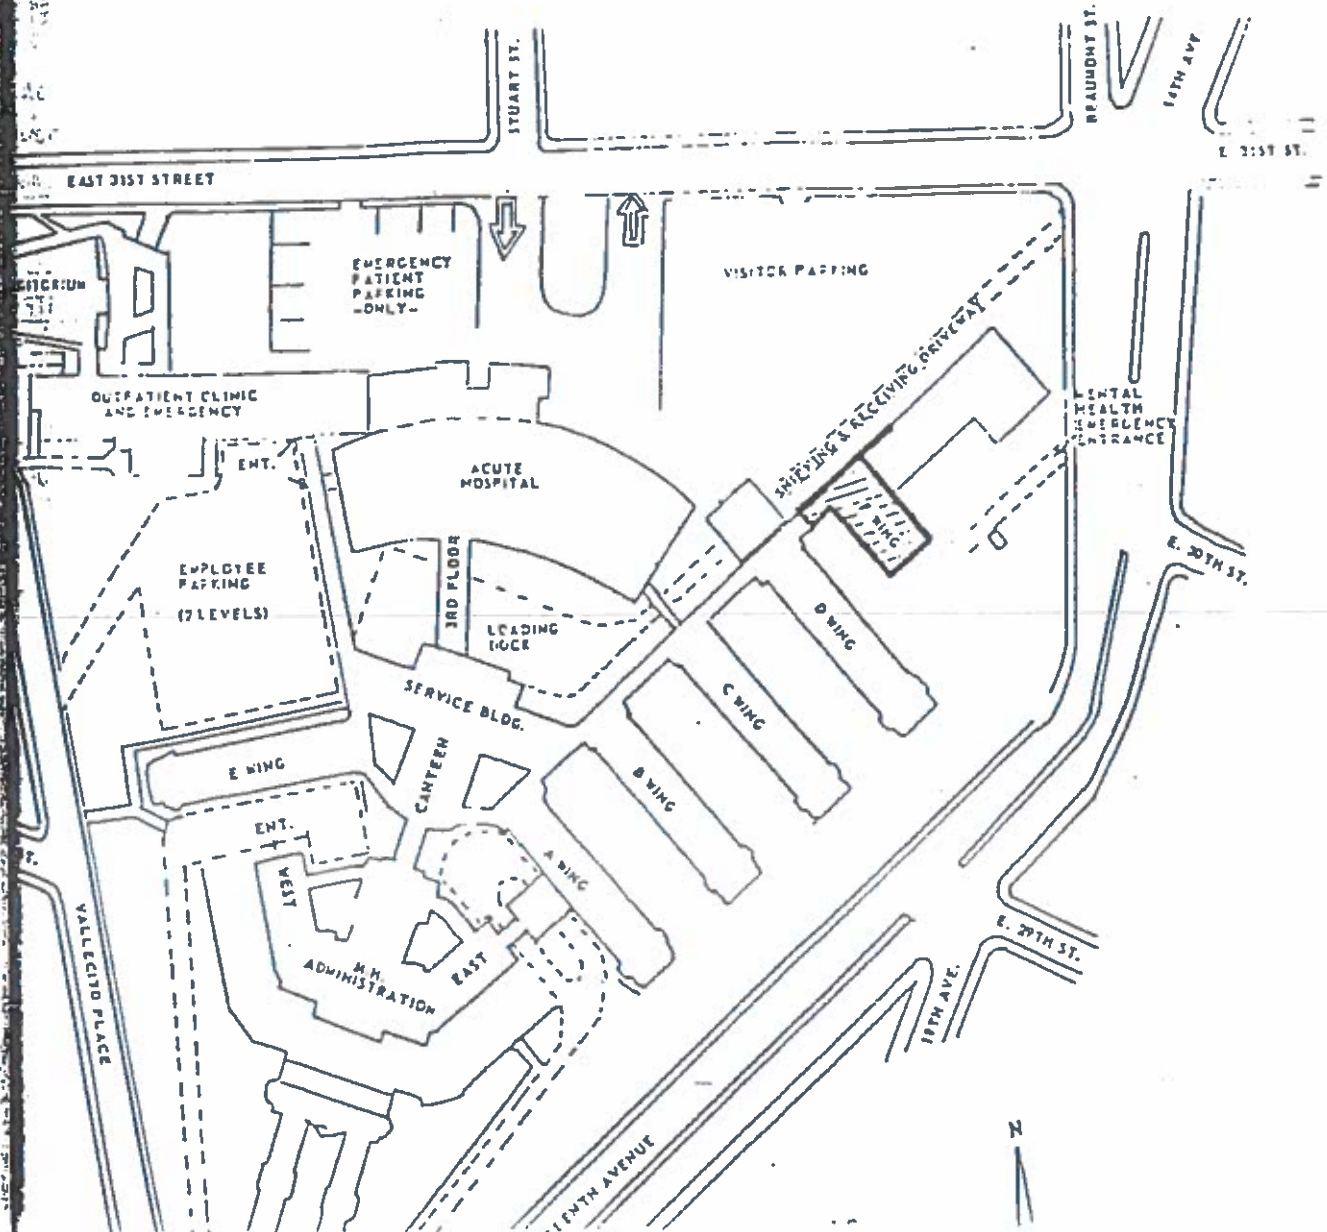
Structural drawings were not available for Wing F. It was assumed to be similar in construction to the other wing buildings. (See "Structural System" for Wings A, B, C, D, & E).

Wing F is assumed to fail the same Title 24 code requirements as Wings A, B, C, D, E, with respect to minimum wall reinforcement, shearwall trim bars, and column tie size and spacing. (See "Structural Deficiencies - Code Requirements" for those buildings).

At a lateral force level of $V = 0.14W$, no significant structural deficiencies were found.

Wing F would be rated Fair to Good according to the University of California Seismic Performance Rating System. This building represents an insignificant life safety hazard.

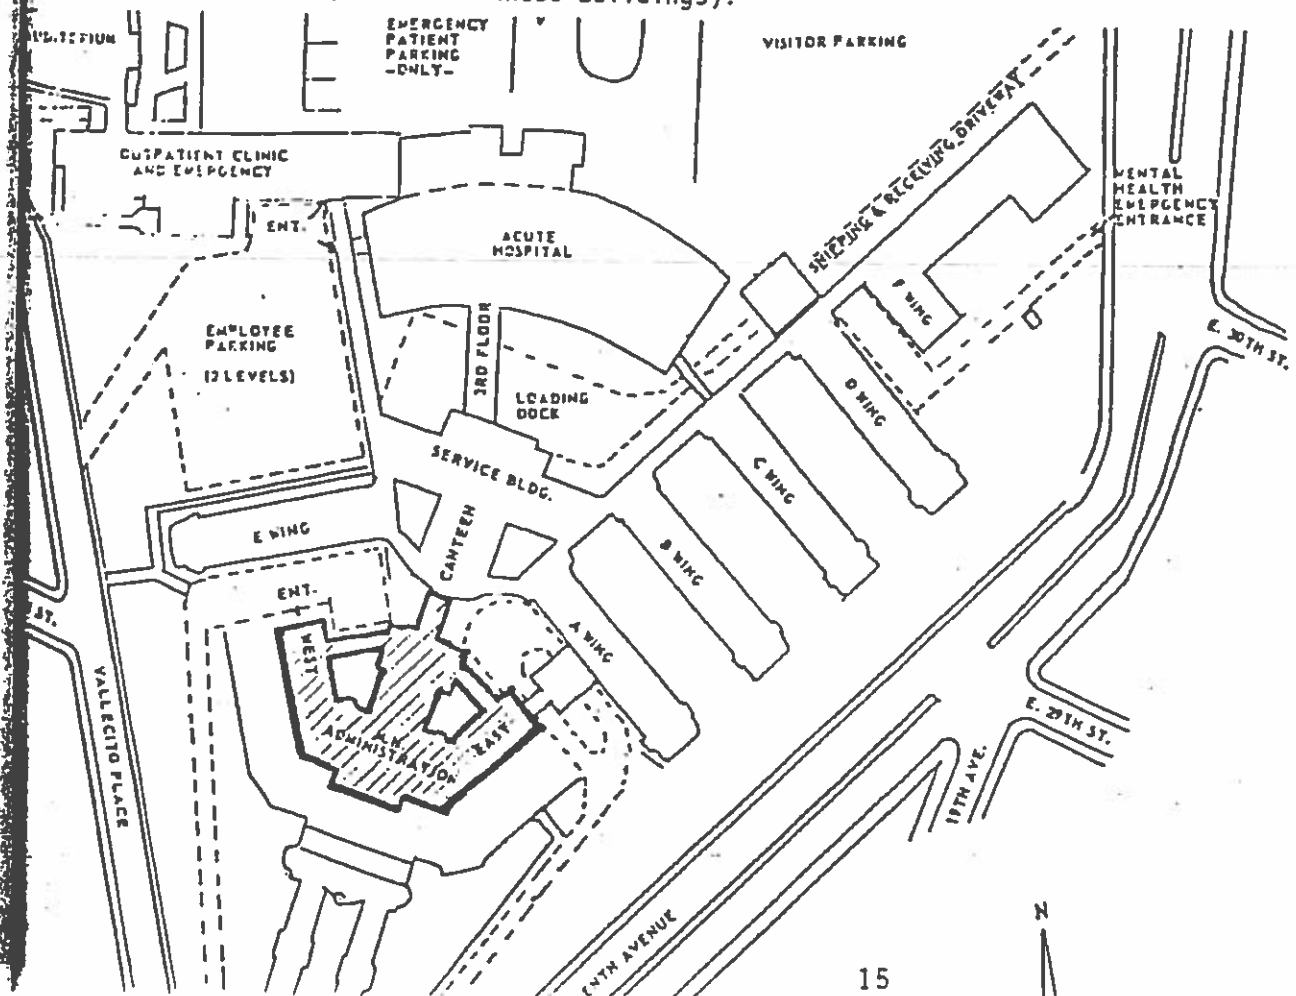
The Administration Building has three wings, A, B, and C, joined to a common front wall. The center wing (A) has a basement, three stories, and a roof with penthouse. The side wings (B and C) have a basement, two stories, and roofs with penthouses and bell towers. Corridors connect the basement and first stories at the rear of the wings (see plans).

The Administration Building is assumed to fail the same Title 24 code requirements as Wings A, B, C, D and E, with respect to minimum wall reinforcement, shearwall trim bears, and column tie size and spacing.

At a lateral force level of $V = 0.14W$, no significant structural deficiencies in the Administration Building were found, using a conventional shearwall analysis (assigning shear to various walls in proportion to their relative rigidities). However, the irregular shape of the building could result in appreciable torsional stresses , and its performance cannot be fully predicted on the basis of a conventional analysis.

The second floor of the Administration Building is interrupted by a raised ceiling at the front (south) wall. During a major earthquake, torsional stresses could cause the second floor diaphragm to fail, leading to a partial collapse of the building.

Due to the highly irregular shape of the building, it is possible that other "weak spots" such as re-entrant corners, vertical and horizontal discontinuities, or interrupted footings and link beams at the back (north) wall of Wing A, could fail due to torsional stresses. The location of extent of problem areas cannot readily be determined

The Administration Building would be rated Fair to Poor according to the University of California Performance Rating System. This building represents possible life safety hazard in its present condition.

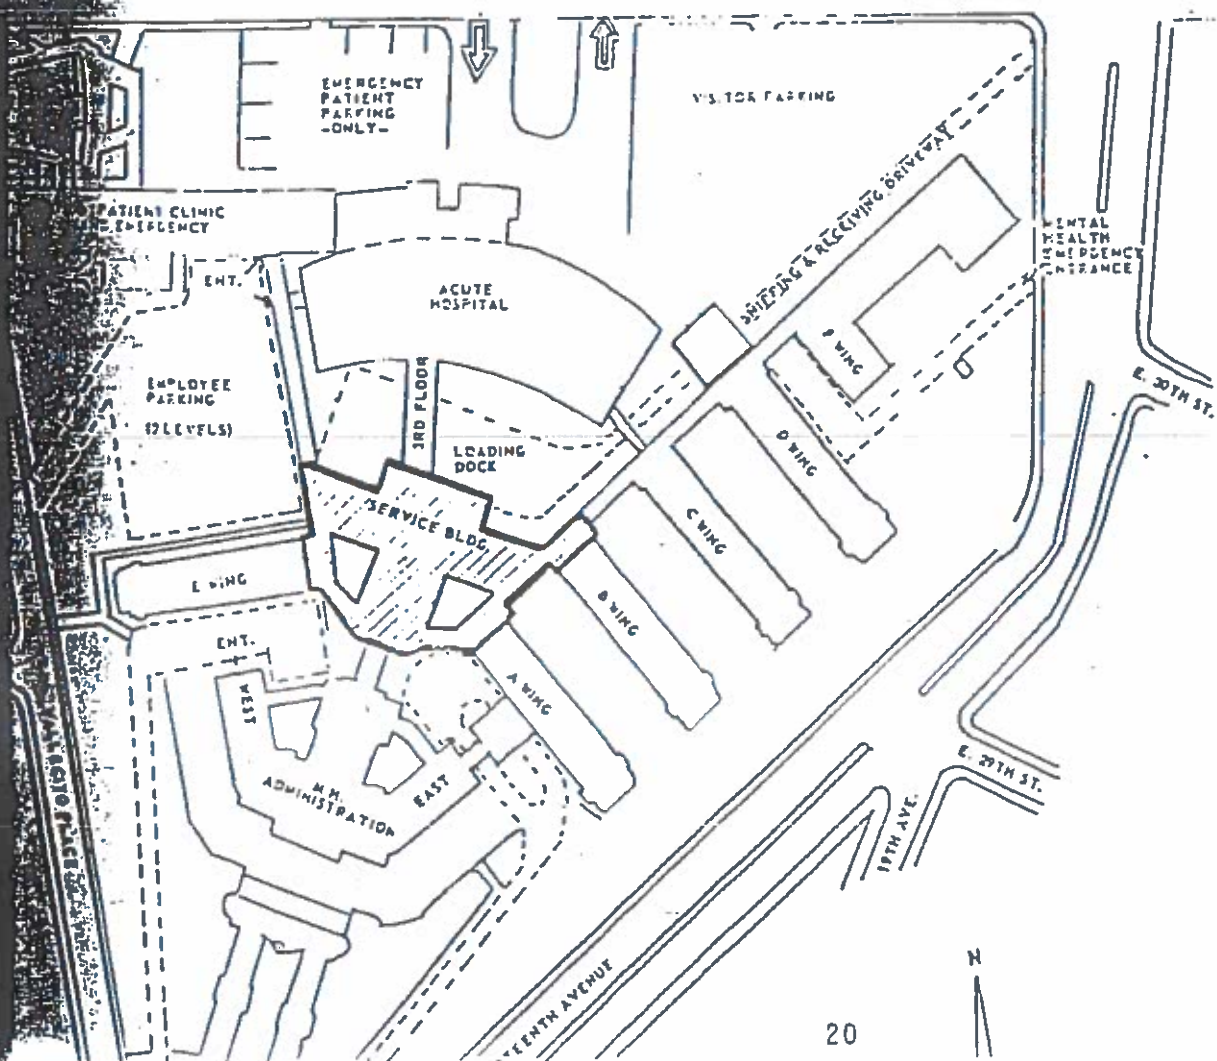
The Service Building is irregularly shaped, with a partial basement, a floor mostly at grade, two upper floors, and a roof with a penthouse raised section. The Service Building was designed by architect [redacted] Meyers, and built about 1919. Reinforced concrete beams, columns, [redacted] walls, and concrete floor slabs support vertical loads. The main portion of the building is supported laterally by two massive diagonal [redacted] shear walls and the very rigid north wall.

The Service Building fails to meet the same Title 24 code requirements as buildings A, B, C, D and E, with respect to minimum wall reinforcement, shearwall trim bars, and column tie size and spacing. (See "Structural Deficiencies - Code Requirements" for those buildings).

Large diagonal shearwalls provide a reasonable level of safety for the center section of the Service Building in a major earthquake. However, due to irregular vertical and plan layouts, the building may experience damage in local areas. The location and extent of damage cannot readily be determined.

Certain corridor areas were analyzed both as part of Wing Buildings and as part of the Service Building. Because of their dual assignment, the Service Building must share the possibility of major damage to these corridor areas. (See "Structural Deficiencies in a Major Earthquake" for Wings A, B, C, D and E.)

The Service Building would be rated Fair to Poor according to the University of California Seismic Performance Rating System. It represents an appreciable life safety hazard in certain areas, but an overall low hazard in the areas supported by massive shearwalls.

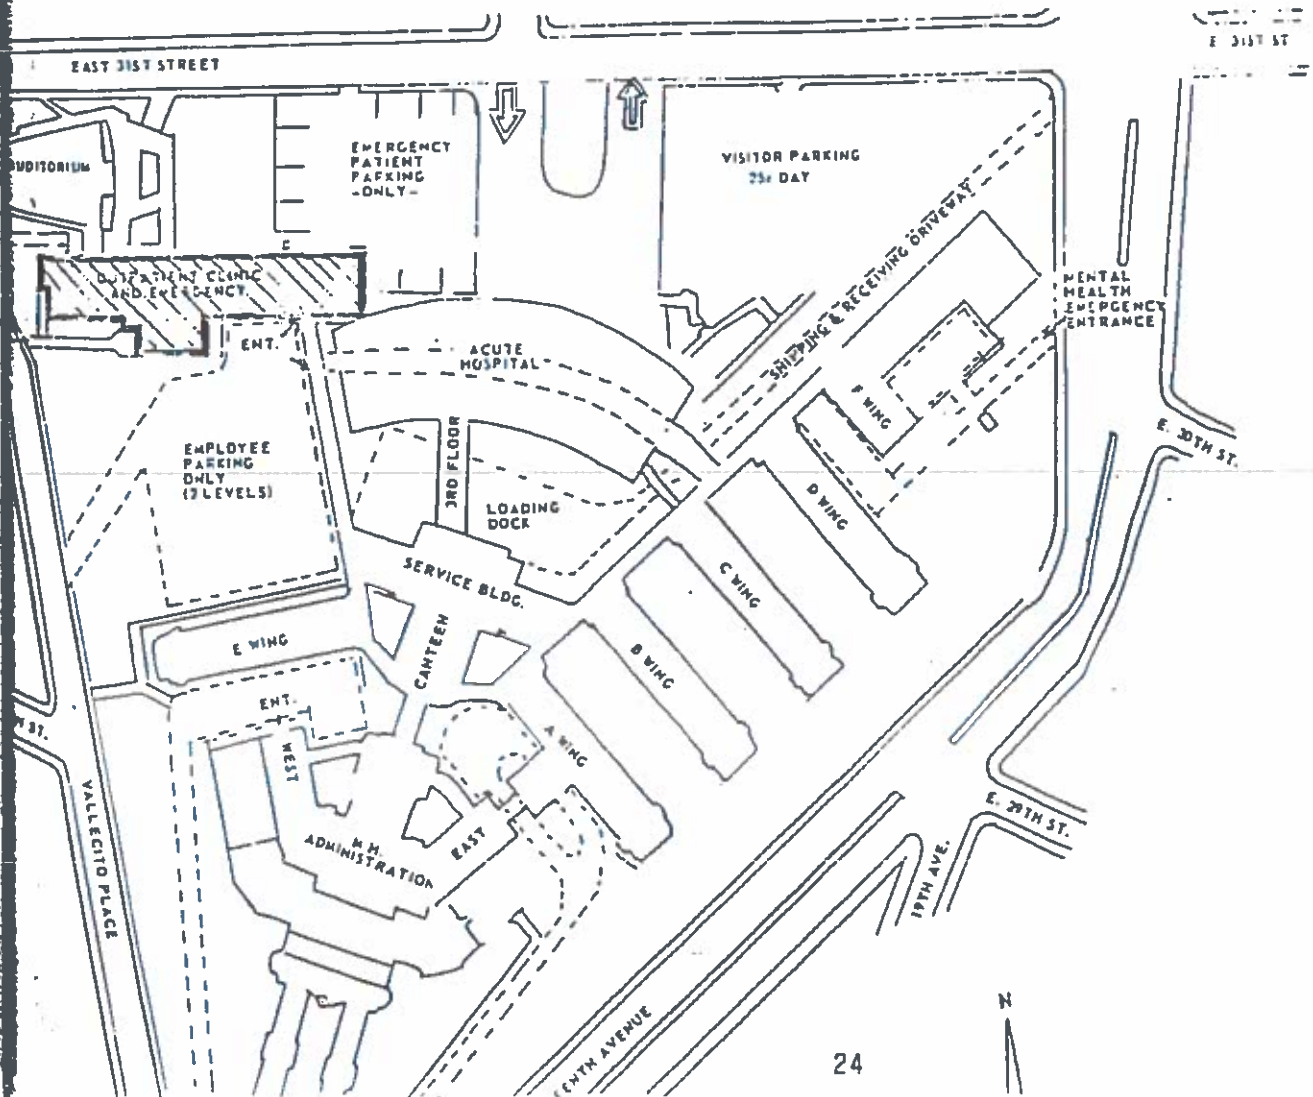
Reinforced concrete columns, beams, bearing walls, joists, and slabs support vertical load. Reinforced concrete shearwalls support lateral loads. (see plan)

2. The exterior wall of the stairway projecting from the south wall would probably also be a hazard, although the mode of failure cannot be accurately predicted.

3. There is a possibility of major damage at the south wall, fourth floor level.

The Clinic would be rated Fair, according to the University of California Seismic Performance Rating System. The building represents a low overall life safety hazard; however, there is possibility of major structural damage and some life safety hazard in local areas of the building, such as the projecting stairwells.

1. Adding additional column ties where spacing is too wide.
2. Adding new shearwalls and reinforcing existing shearwalls, including adding foundations, to meet current lateral force requirements.
